PROTECTING OUR WATER SUPPLIES AND COMMUNITIES

Southwestern Water Conservation District
Annual Seminar

COLORADO
Division of Water Resources
Department of Natural Resources

Dam Safety Branch

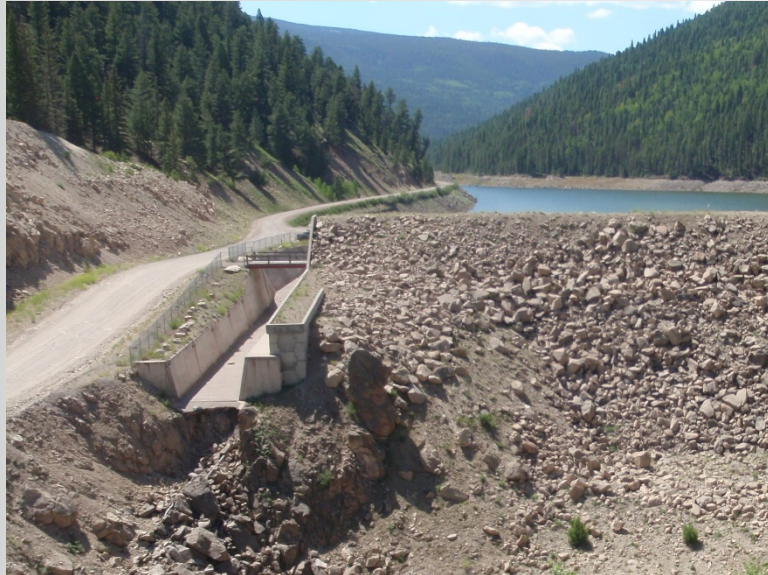
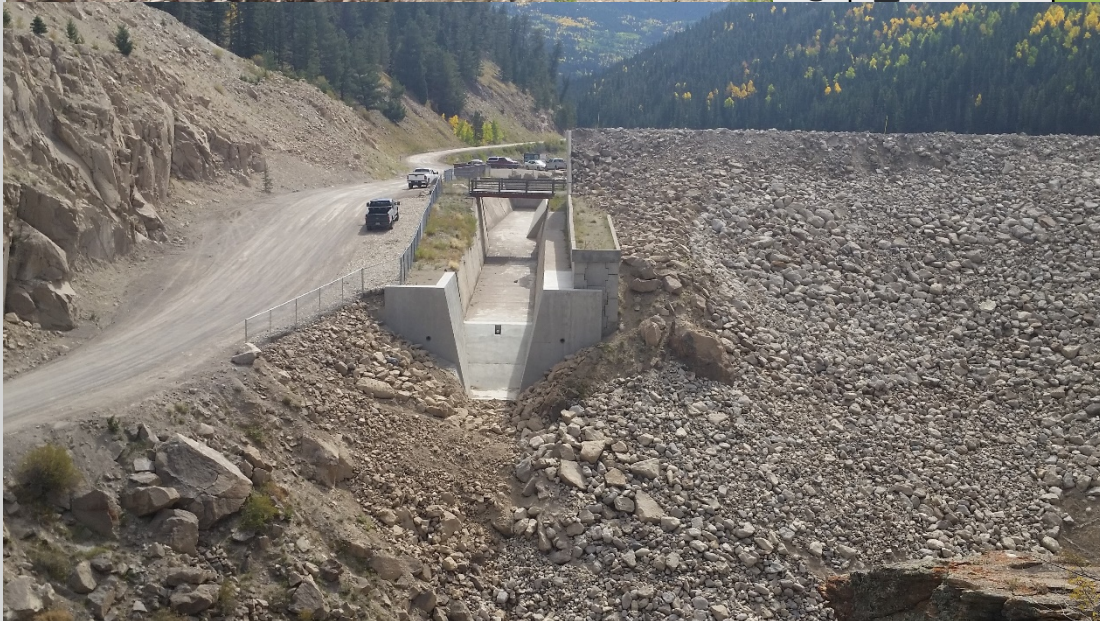
Risk Informed Decision Making

Likelihood of Failure	Very High	Yellow	Red	Red	Red
	High	Yellow	Yellow	Red (circled: PFM 18 (existing))	Red
	Low	Green	Green	Yellow	Red
		Level 1	Level 2	Level 3	Level 4
Consequences
